PROPERTY CONDITION ASSESSMENT

**Stephanie Drive
Salinas, California 93906**

PREPARED BY
Gassia Salibian, Architect
California License No. C28653

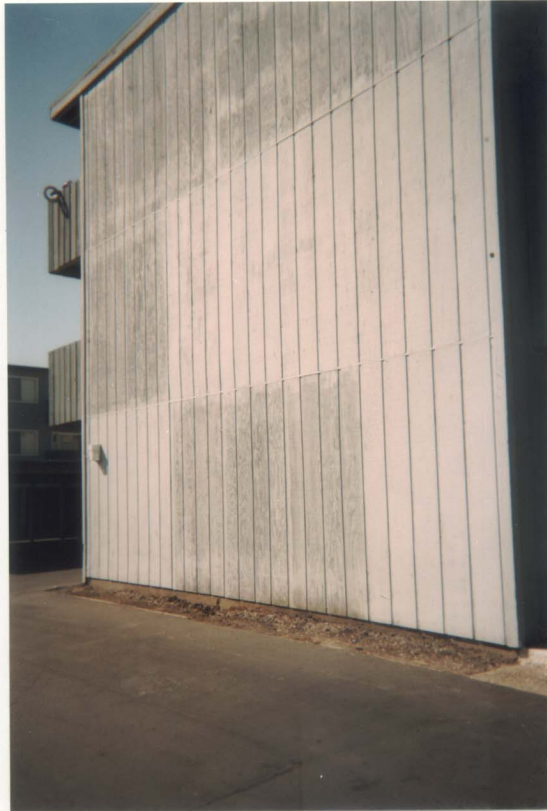
Building exteriors were painted in June of 2002. The painted T1-11 siding on the exterior walls appears to be in fair condition except for southern and western exposure areas where moderate to extensive sun damage appears to have compromised the surface and appearance (photo 4). Some areas of walls near grade level are soiled from exposure to the adjacent ground. Paint colors are two toned blue-grey colors, with wall surfaces of the a lighter tone and balcony

PHOTO 4: Patched T1-11 siding with old sheets exhibiting sun and moisture damage at south facades

- Replace all T1-11 siding mostly at south and west facades that exhibit sun damage with new siding and proper weatherproofing membranes. Replace rotted T1-11 siding up to two feet in height all along the base of the buildings with the same;
