AllWest Environmental

PROPERTY CONDITION ASSESSMENT

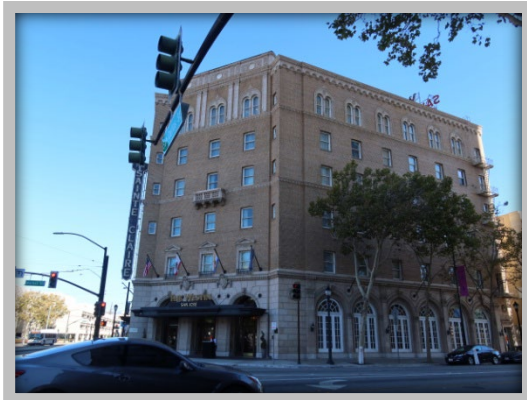
302 S. Market Street, San Jose, CA 95113

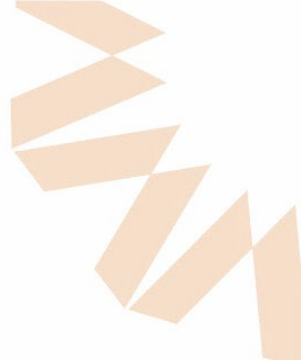
**Reviewer's Name and Title
California License No. C-xxxxx**

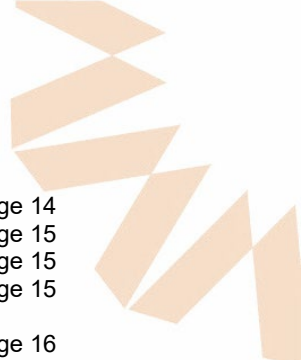
F.06	Fire Protection	Page 14
F.07	Other Systems	Page 15
F.08	Security System	Page 15
F.09	Vertical Transportation and Conveying Systems.....	Page 15
G.	<u>Accessibility Compliance</u>	Page 16
G.01	Parking	Page 16
G.02	Path of Travel	Page 16
G.03	Toilets/Plumbing Fixtures	Page 16
G.04	Elevators	Page 17
IV.	CONSULTANT'S QUALIFIERS	Page 17
FIGURES	Regional Map, Vicinity Map, and Aerial Photo	
PHOTOGRAPHS	Photos 1 through 108, M-1 through M-25, E1 through E40	
APPENDIX A	Building permits, Certificate of Occupancy Parcel Map, FEMA Flood Map	
APPENDIX B	ALTA Survey, ADA Assessment, Vendor Agreements Previous Condition Assessments	
APPENDIX C	MEP Equipment List, MEP Load Calculator, MCA Building Enclosure Assessment, VDA Vertical Transportation Evaluation	
APPENDIX D	Authorization for Reliance and General Conditions

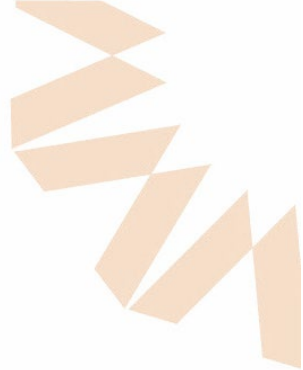
PROPERTY CONDITION ASSESSMENT

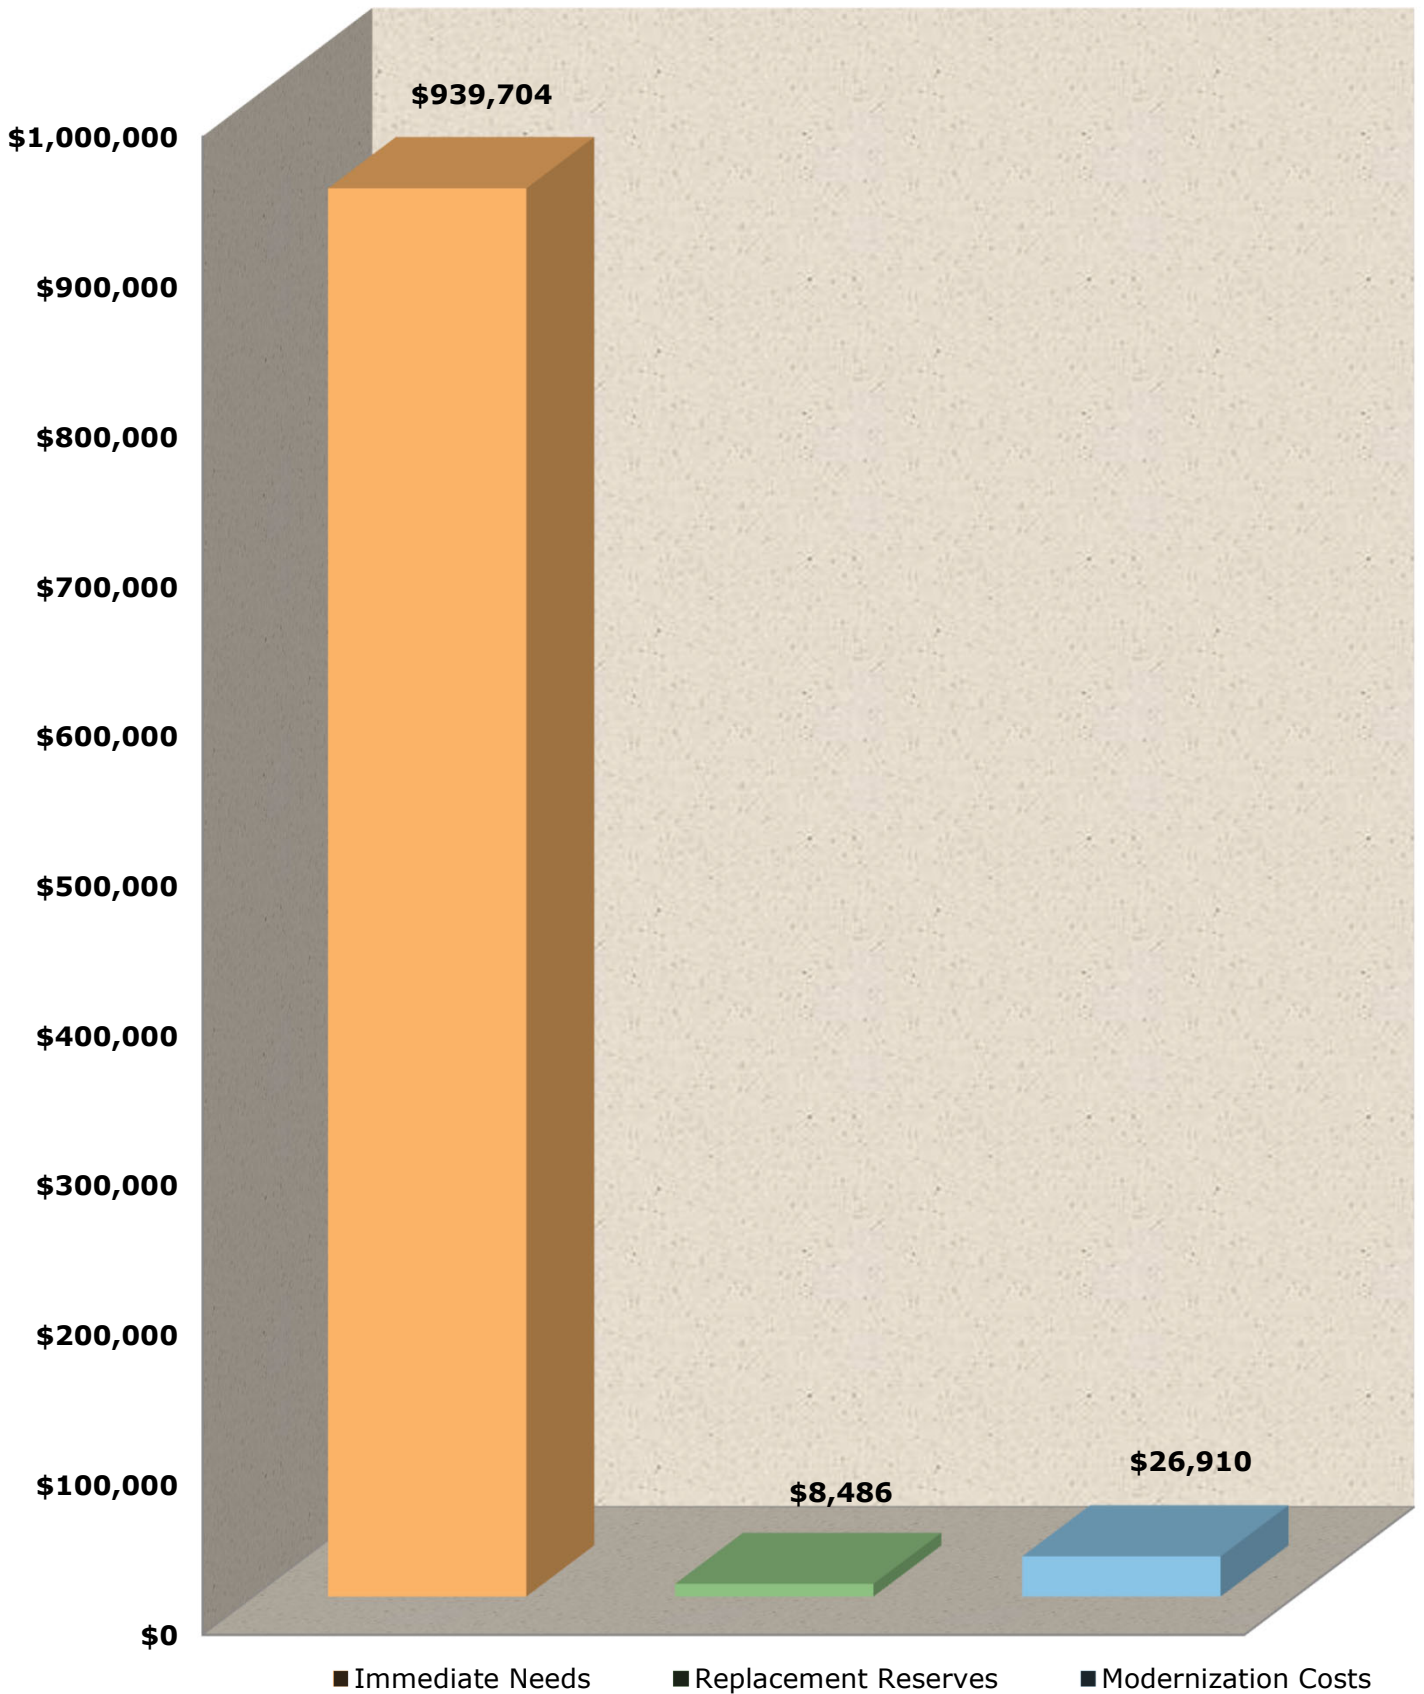
The five-year replacement reserve is estimated at **\$8,486** which includes a 2.5 % per year inflation factor. Expenditures include the façade maintenance program.

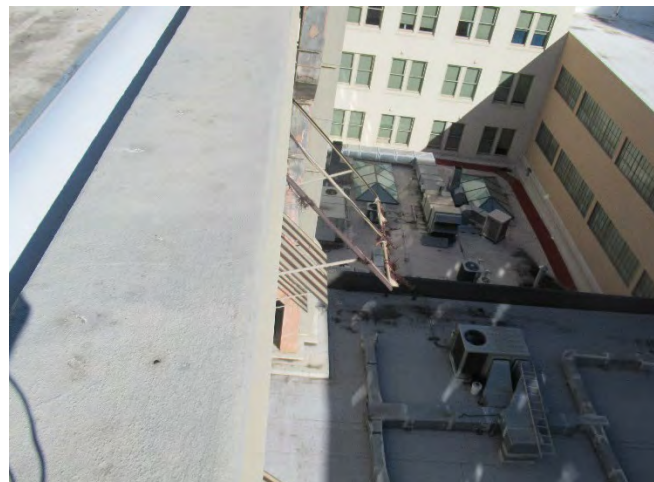
18. Several cloth awnings, installed over some of the courtyard windows are either missing or ripped. As an optional Modernization cost, the awnings and brackets should be replaced on windows where they were previously installed.

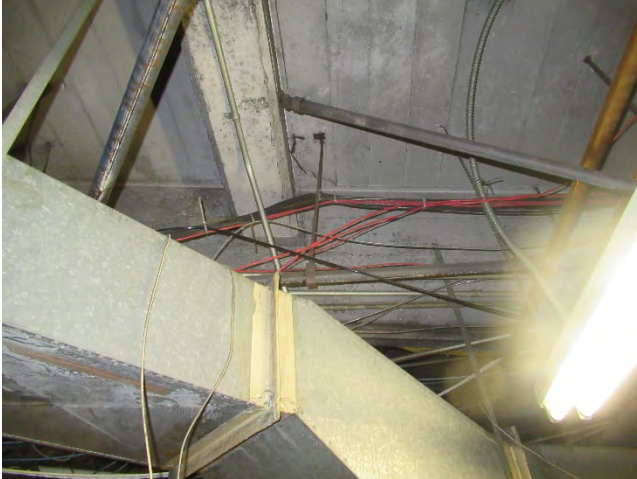
19. Building structure is framed with concrete girders and beams, with concrete floors.

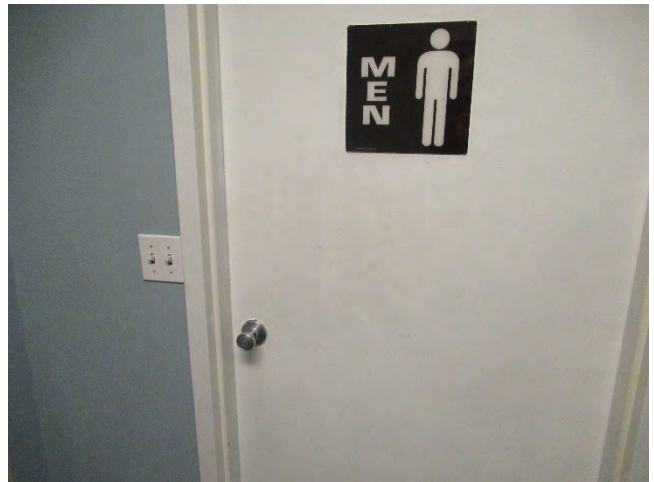
82. The door to the employee Men's Lockers and restroom. The door knob is Non-Accessible, and should be replaced. There is no Accessible jamb signage which should be provided.

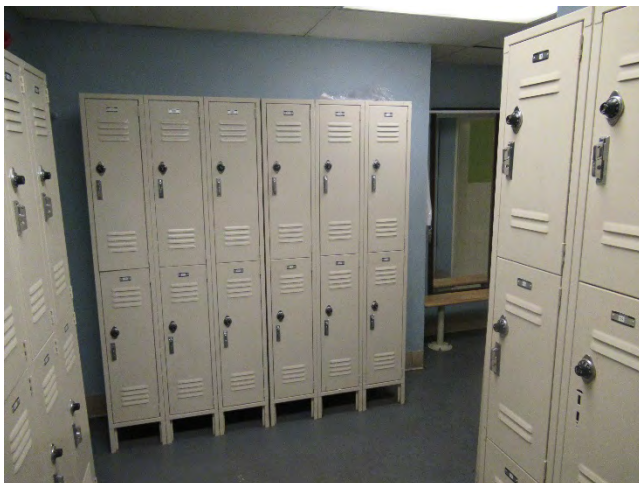
83. The employee Men's Locker room.

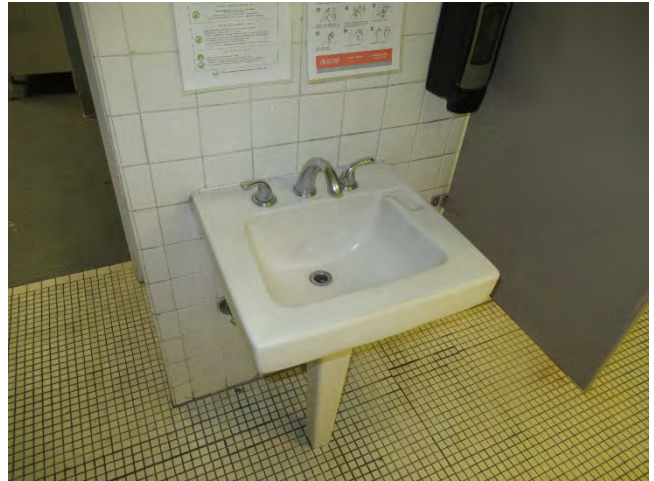
86. Lavatory in the men's locker bathroom. It should be replaced with one compliant for Accessible knee space.

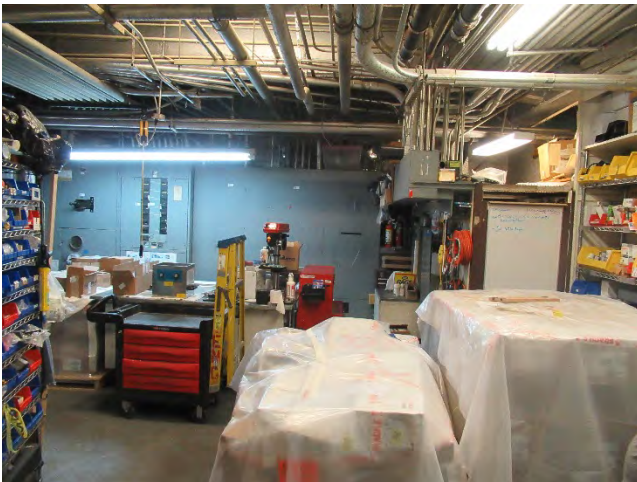
87. The Engineering Workshop in the basement.

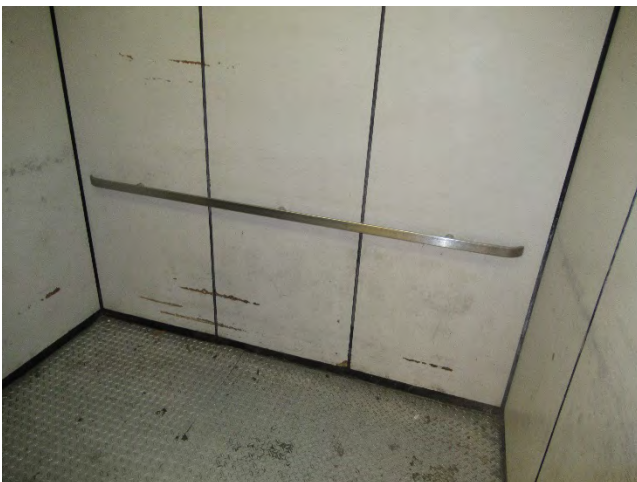
101. Floor and wall finishes in the Kitchen elevator. This elevator is in poor condition and should be modernized.

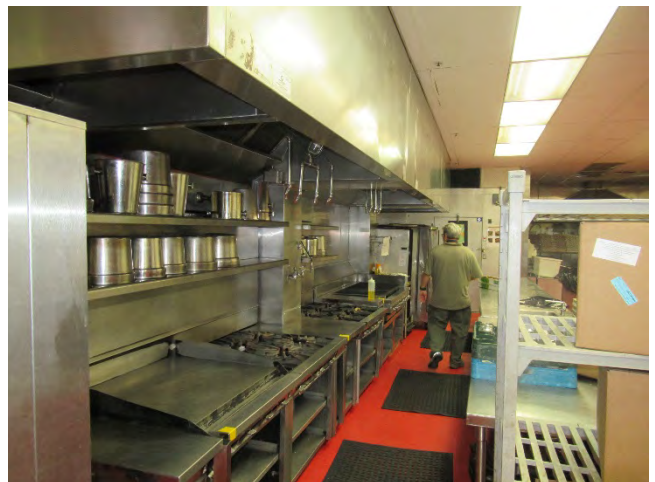
102. The first floor restaurant kitchen.

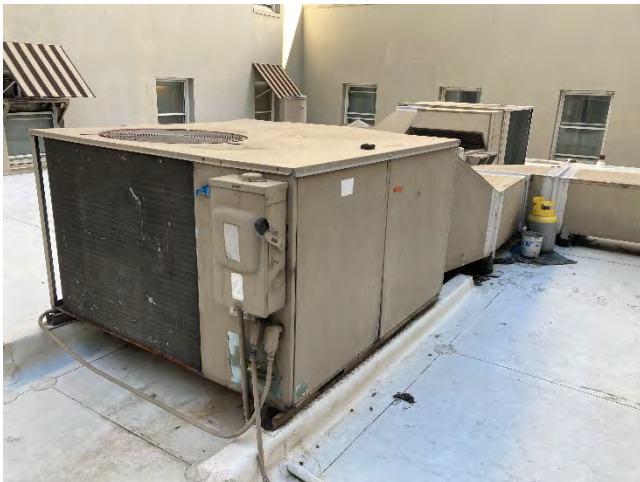
M-3. 10-ton packaged air conditioner.

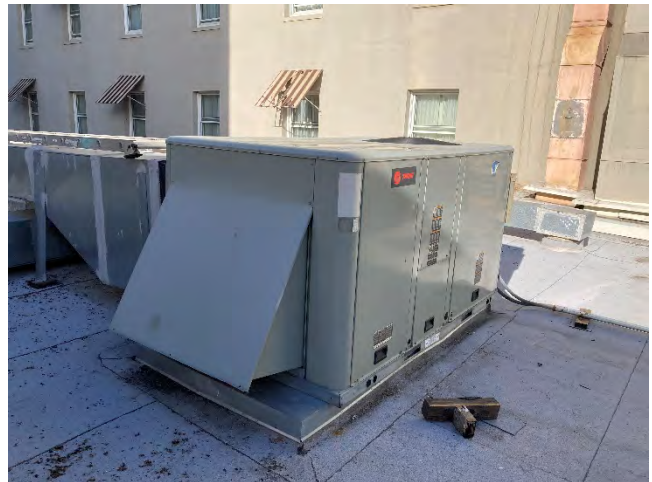
M-4. 20-ton packaged air conditioner.

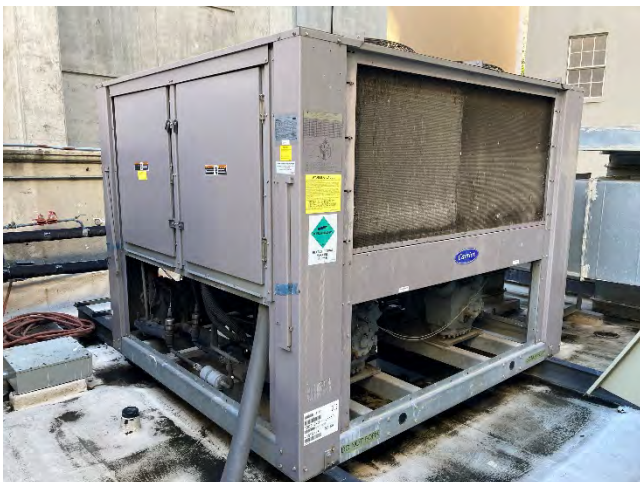
M-5. 45-ton air cooled chiller.

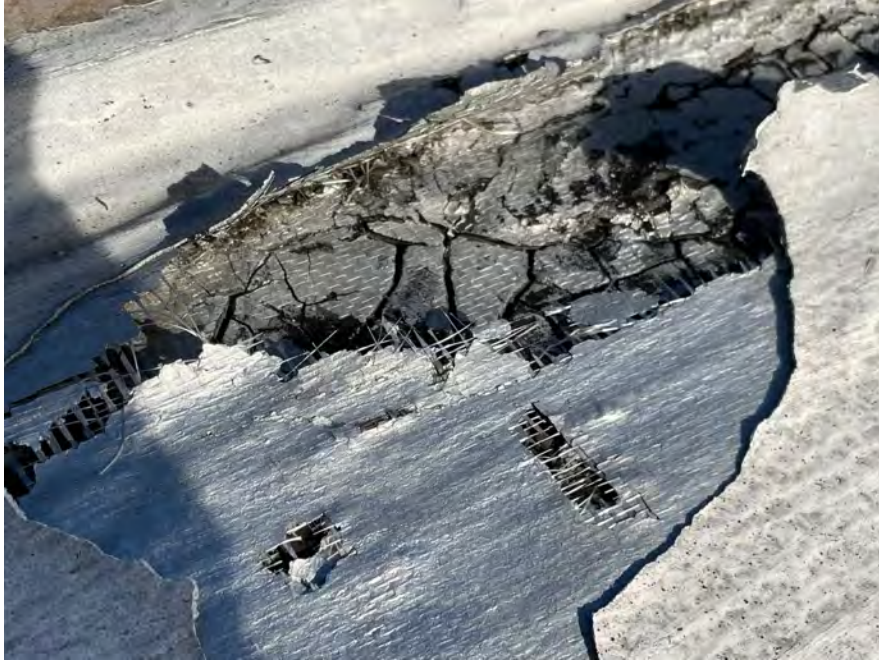
E - 5: Typical damage at Main Roof

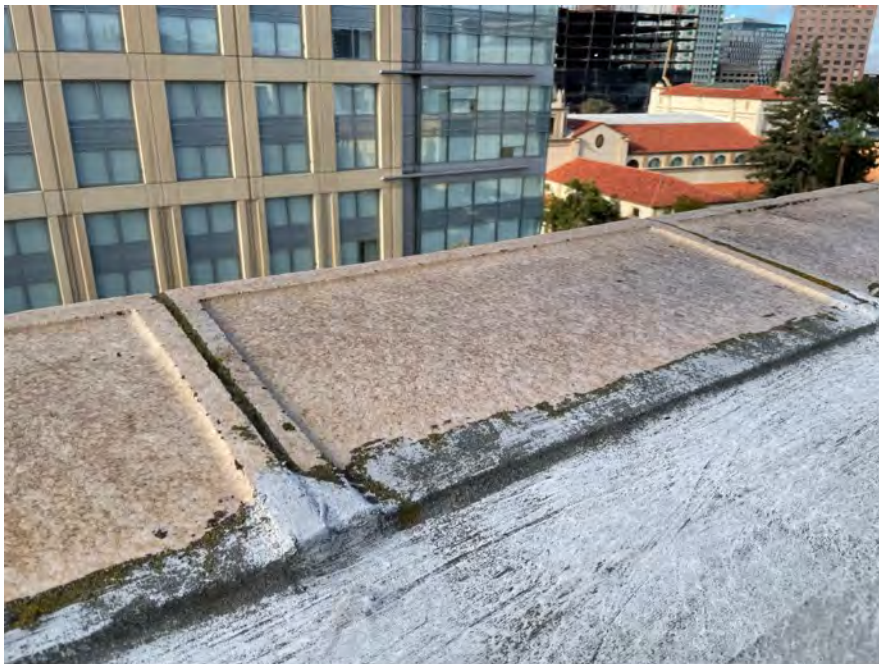
E - 6: Bio-growth at mortar and on coating

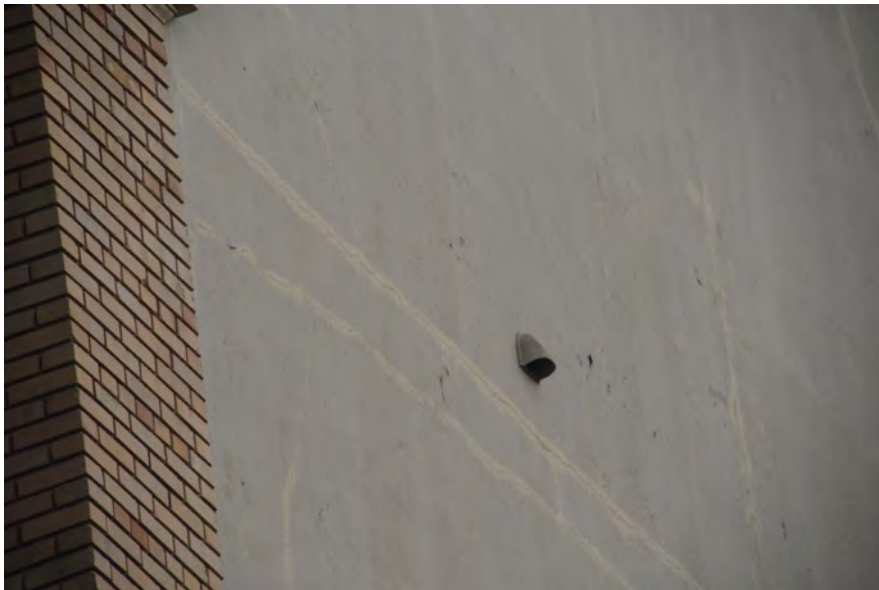
E - 24: Cracks at floor lines

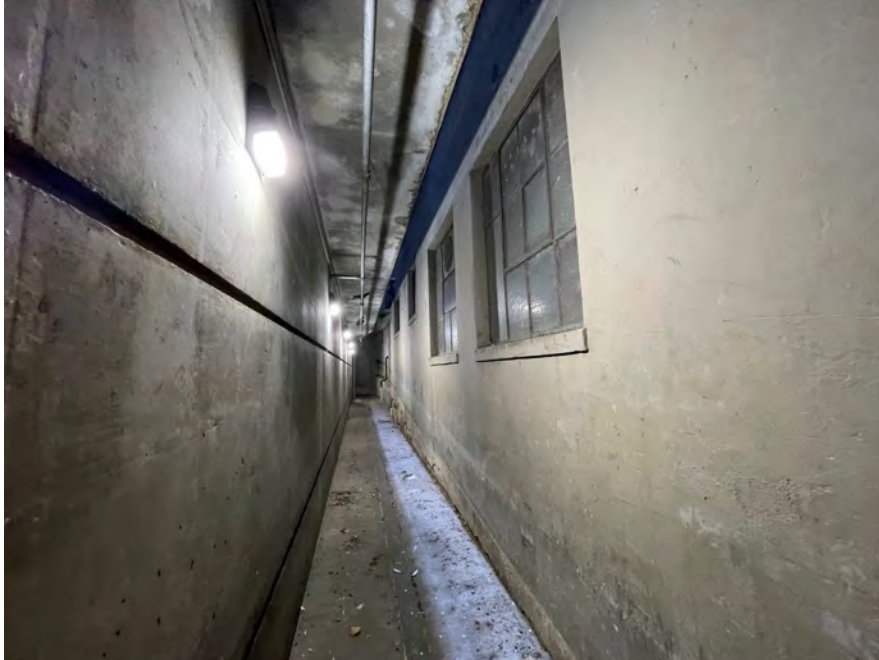
E - 25: Painted concrete at back wall

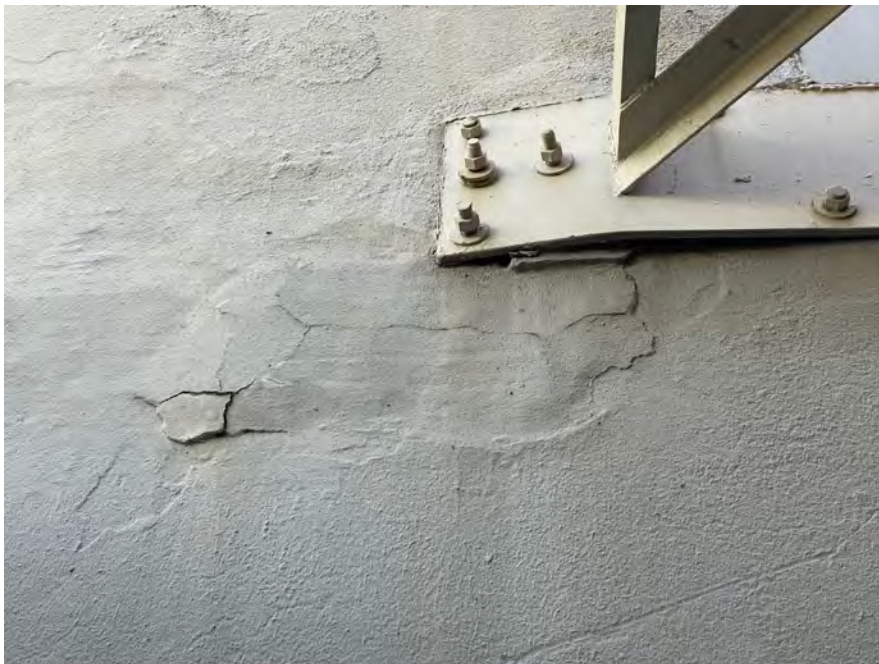
E - 26: Stucco spalls

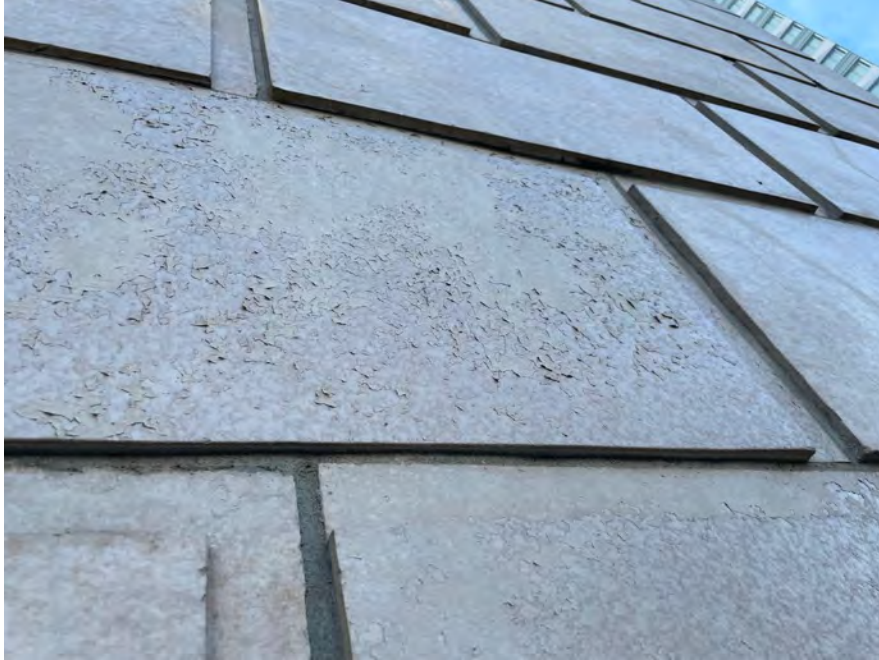
E - 27: Peeling paint on terra cotta

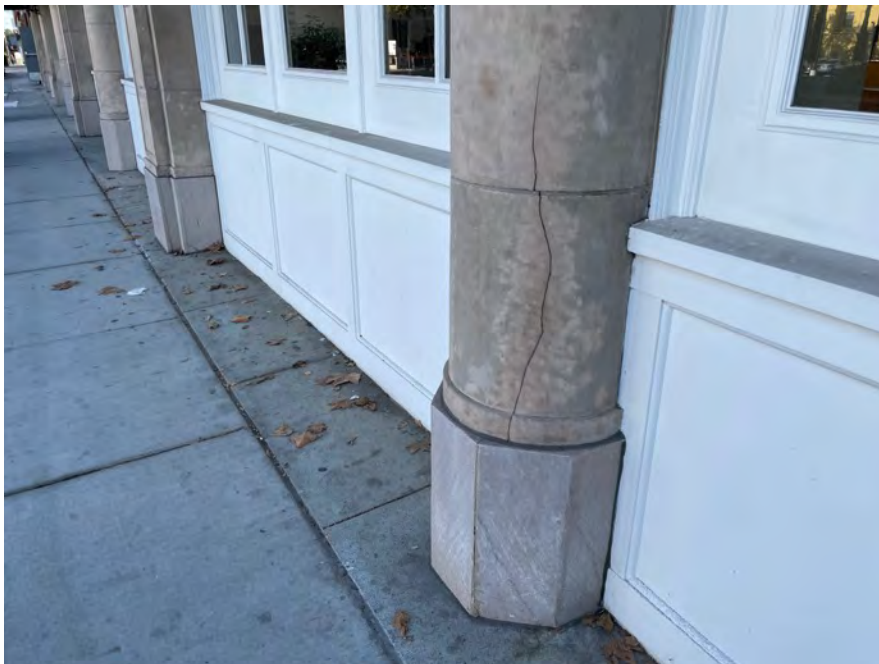
E - 28: Crack at column

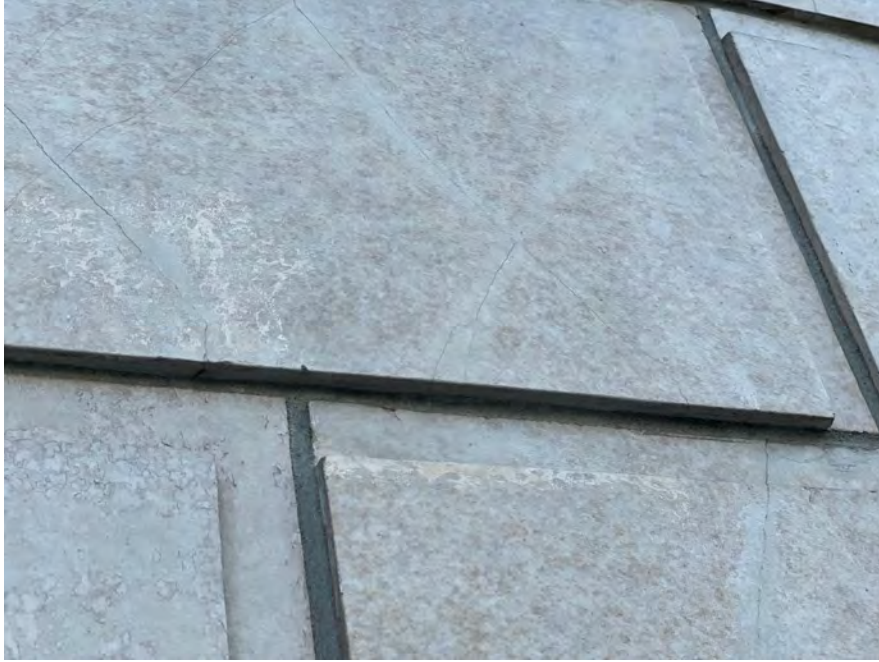
E - 29: Previously remediated cracks

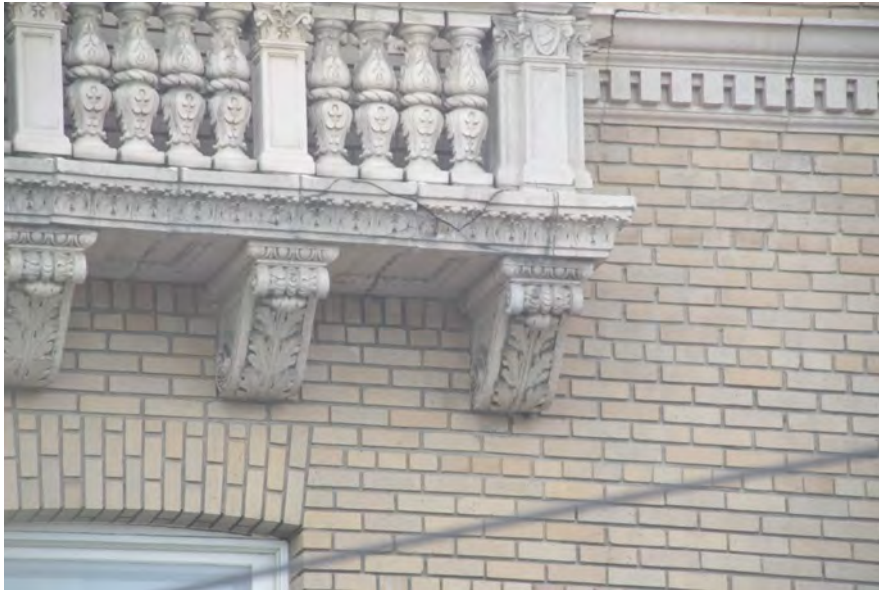
E - 31: Cracks at balcony

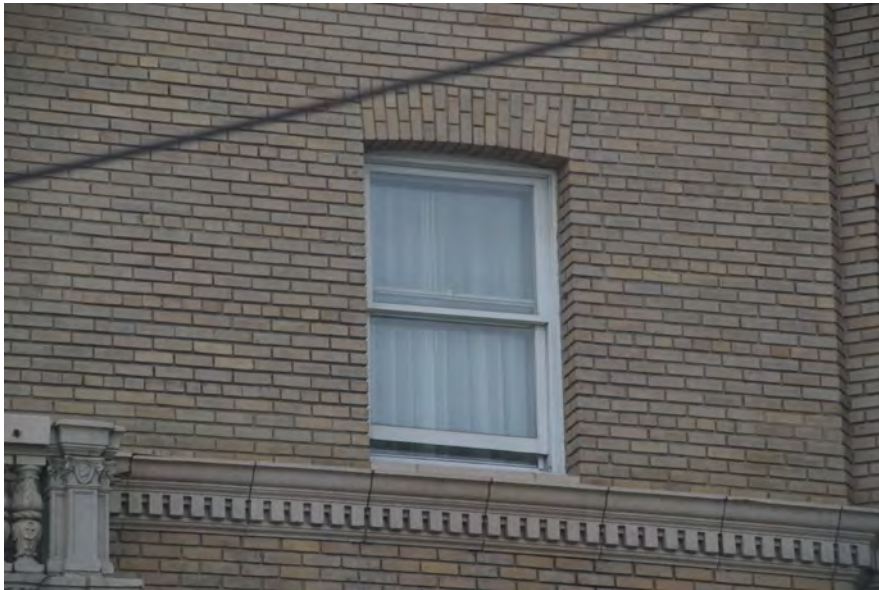
E - 32: Typical window
