# AllWest Environmental

## ENVIRONMENTAL SITE ASSESSMENT

**The Westin San Jose, 302 S. Market Street, San Jose, CA 95113**

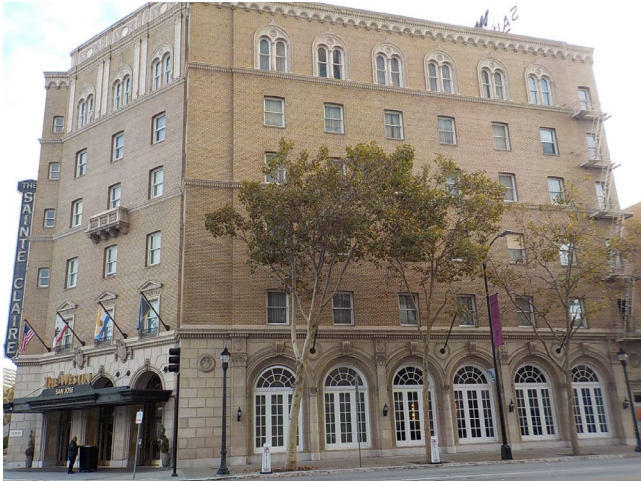
1. Northwestern and Western Façades of Building

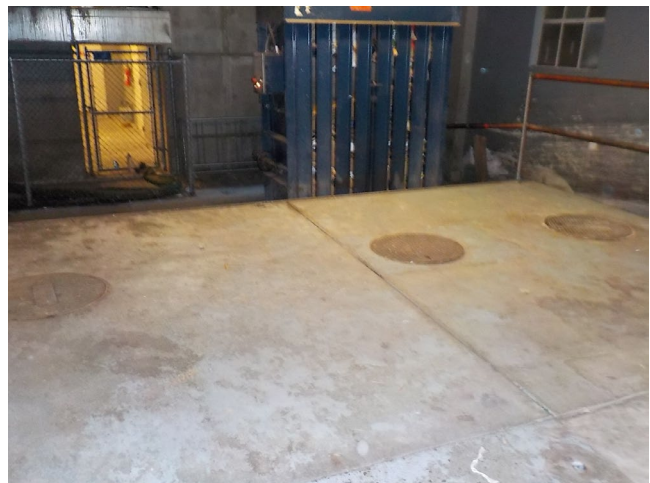
A large grease interceptor for the Il Fornaio restaurant kitchen is located in the eastern loading dock; access covers on top of the interceptor were observed in the concrete loading dock surface. Pumping of the interceptor contents on a periodic basis was reported by the site representatives.

6. Eastern Loading Dock with Grease Interceptor in Dock and Box Crusher Adjoining Dock

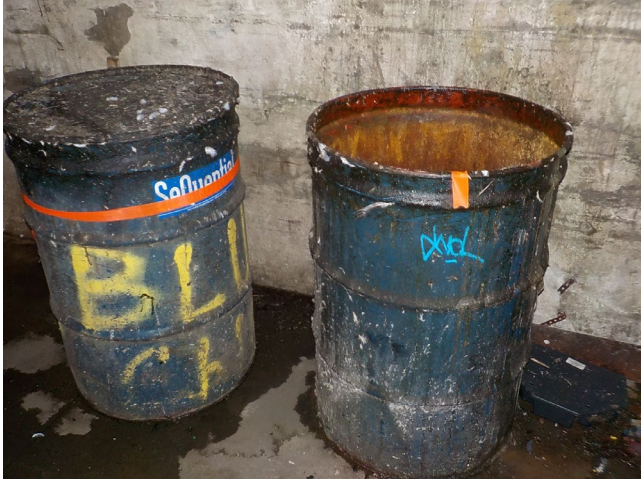
7. Waste Cooking Oil Drums in Eastern Loading Dock Area

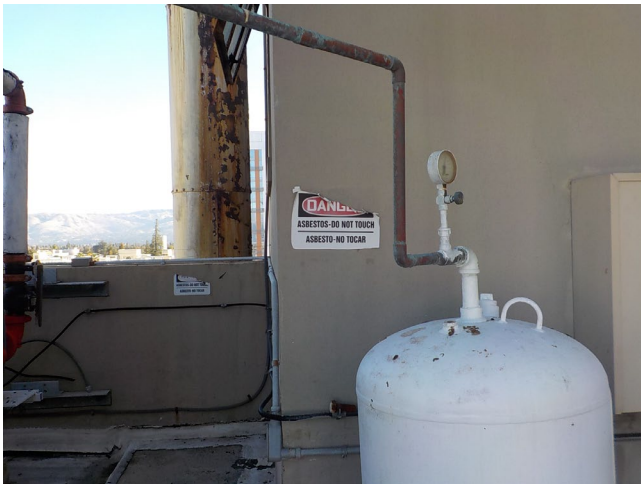
As part of this environmental assessment, AllWest observed the building premises for potential ACM such as floor coverings, ceiling and wall materials, bulk insulation and fireproofing. Observed materials appeared generally in good condition, with some damaged vinyl flooring and gypsum board walls in the back of house and utility areas. Exterior walls adjoining the rooftop cooling towers were labeled as asbestos-containing. Building personnel had no additional information on what materials the labeling referred to.

9. Wall Area on Roof Labeled as Asbestos

Based on the age of the building, completed in 1926, ACM may remain present in areas not significantly renovated since that time. We recommended an asbestos-containing building materials O&M program be implemented. An O&M program details procedures designed to ensure that asbestos containing building materials, whenever possible, remain undisturbed to minimize the likelihood of exposing building tenants and workers to airborne asbestos fibers.

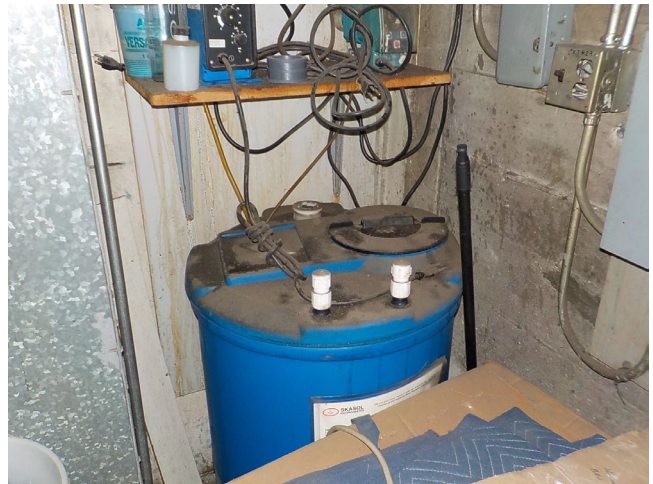
10. Cooling Tower Water Treatment Chemical Container in Rooftop Elevator Room Penthouse

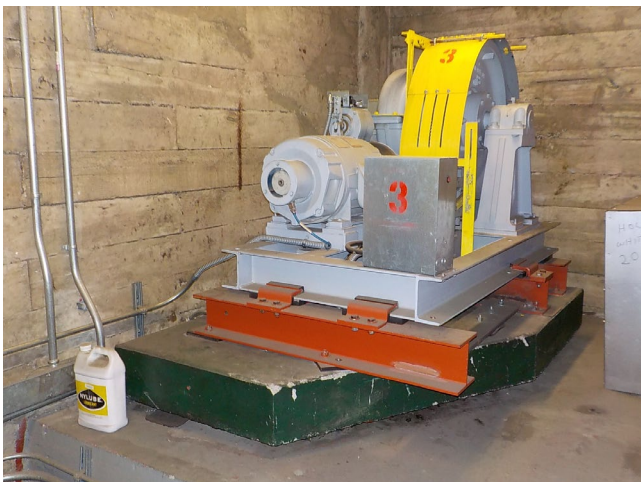
3. **MECHANICAL AND HVAC SYSTEMS:** HVAC equipment includes rooftop units, exhaust fans and cooling towers. Natural gas-fired boilers and air supply units are present in the hotel basement.
4. **BUILDING EQUIPMENT:** Two passenger elevators and one service elevator, all overhead traction units, serve the basement through 6<sup>th</sup> floor of the hotel. These elevators reportedly were modernized in 2017 and appeared in good condition.

11. Traction Elevator Motor in Rooftop Elevator Room Penthouse

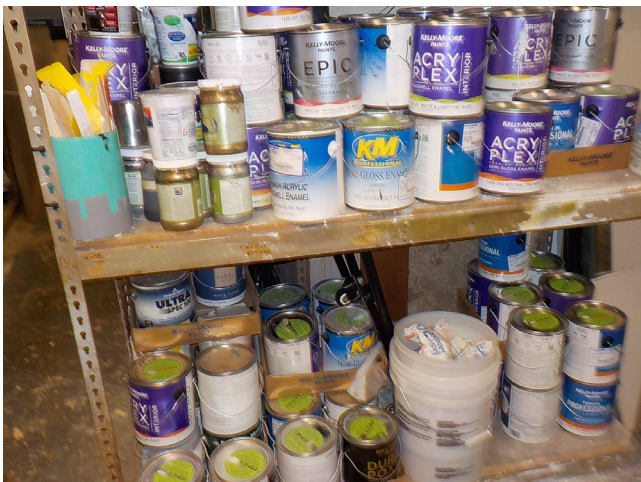
17. Paint Storage in Basement Paint Room

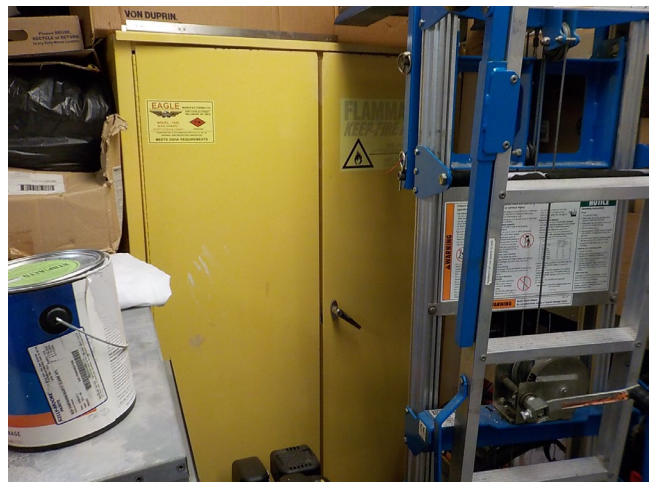
18. Flammables Cabinet in Basement Paint Room

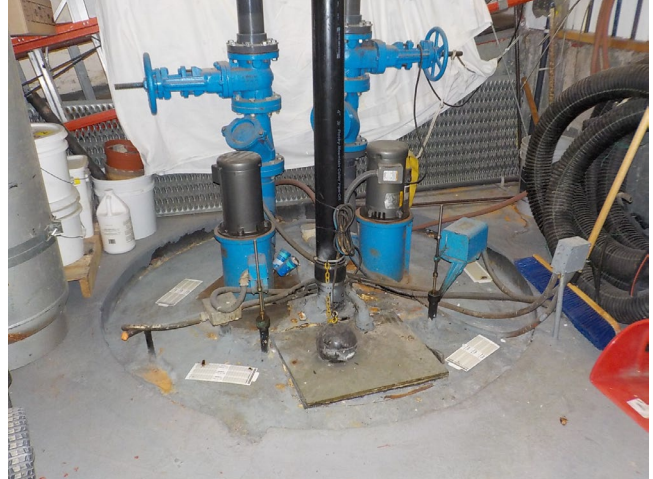
8. **SUMPS:** A 3,000-gallon sewer sump was observed in the basement boiler room. Equipped with two pumps, the sump reportedly is discharged to the municipal sanitary sewer system.

20. Sewer Sump in Basement

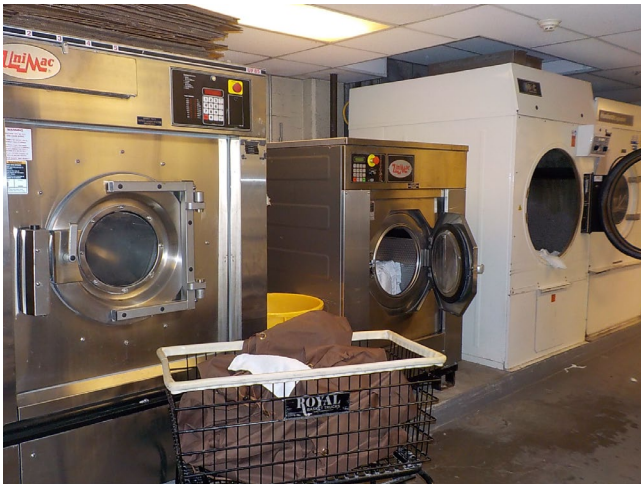
5. **INDUSTRIAL EQUIPMENT:** Laundry facilities for hotel linens are located in the basement. Several commercial washers and dryers were observed in the laundry room. No dry cleaning is conducted at the hotel and reportedly was not anticipated to have been conducted historically,

21. Basement Hotel Laundry Room

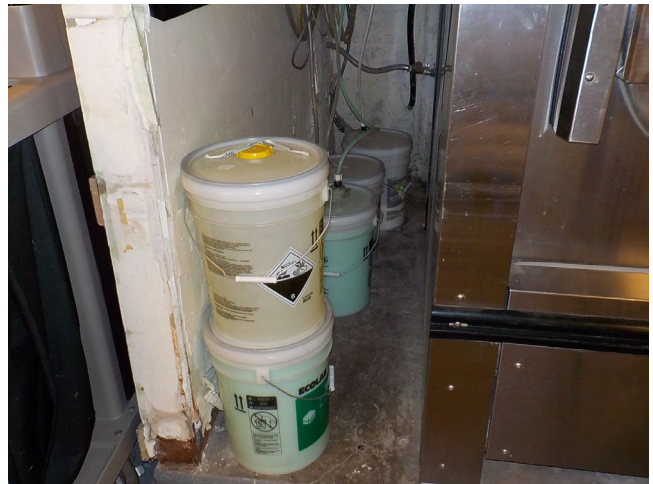
22. Laundry Detergents/Additives in Basement Hotel Laundry Room

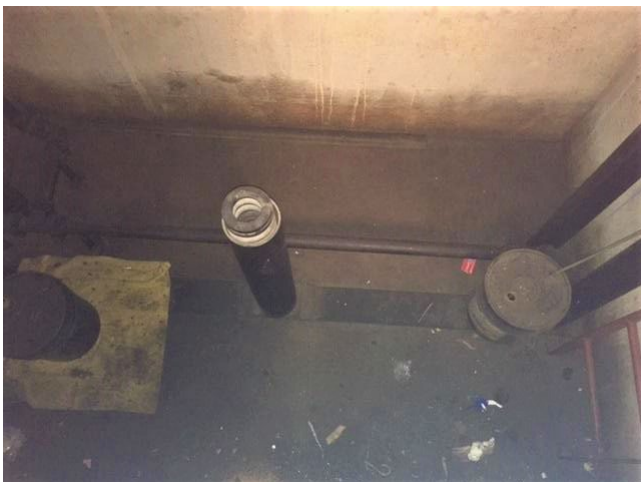
A hydraulic kitchen elevator serving the basement and 1<sup>st</sup> floor was installed in 2002 and is in poor condition, appearing unmaintained. Observation of the hydraulic elevator pit by the elevator consultant revealed visual evidence it previously had been filled with hydraulic fluid.

23. Hydraulic Kitchen Elevator Pit with Evidence of Previous Hydraulic Fluid Accumulation

Further discussion of the elevator systems at the subject property, as well as recommendations, are included under separate cover.

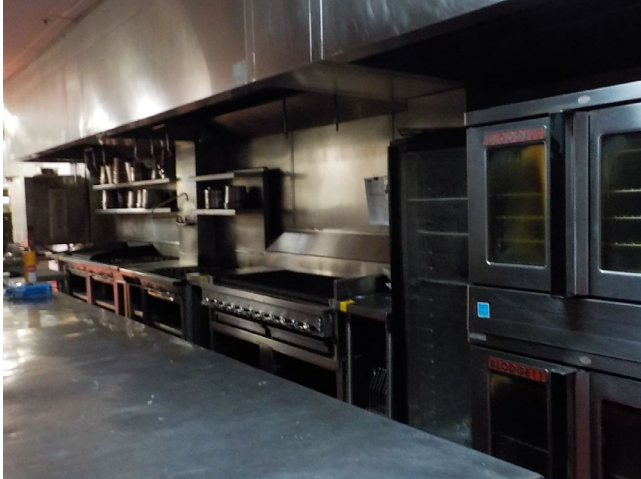
A variety of commercial kitchen equipment was observed in the on-site Il Fornaio restaurant kitchen. As discussed in Section D.8, a subgrade grease interceptor for the kitchen is located in the eastern loading dock.

25. Il Fornaio Kitchen
